# Building Surveys and Reports

4<sup>th</sup> Edition

**James Douglas BSc, MRICS, MBEng, FHEA  
and Edward A. Noy FASI, ARSH**

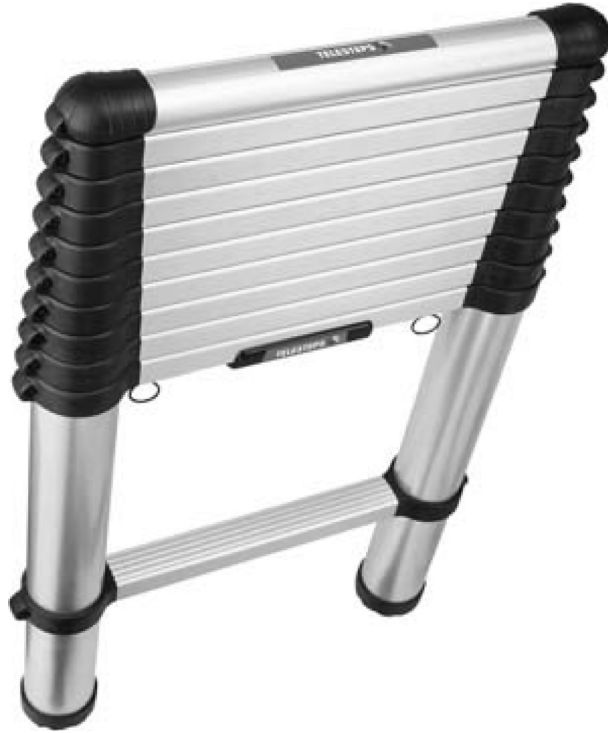
**Figure 2.2** Telesteps® telescopic ladder (courtesy of The Telescopic Ladder Company Ltd).

- When no builder is involved it is often necessary to gain access to high ceilings and roof spaces. A telescopic aluminium ladder capable of extending to about 3 m will meet this need, and will be found useful for most surveys. This type of ladder is usually about 1 m long when retracted and can easily fit into a car (see Figure 2.2).

- Telescopic ladder (around £200 at 2010 prices) (Figure 2.2). A fairly recent innovation is the use of a telescopic ladder for building inspection purposes. It is only about 0.75 m in height when closed but can stretch to 3.3 m when fully extended.
- Electronic moisture-reading meter (around £350 at 2010 prices) (Figure 2.3).
- 2 m folding rule and 5–8 m retractable steel tape.
- Laser distance measuring meter – 30 m range (accurate to  $\pm 1$  mm).
- Torch (5 million candle strength) for attic/sub-floor inspections.
- 20× magnification (minimum) binoculars to facilitate inspection of roofs and chimneys.
- Digital camera (5 million pixel minimum).
- Spirit level to check levels of floor.
- Plumb bob to check verticality of walls and columns.

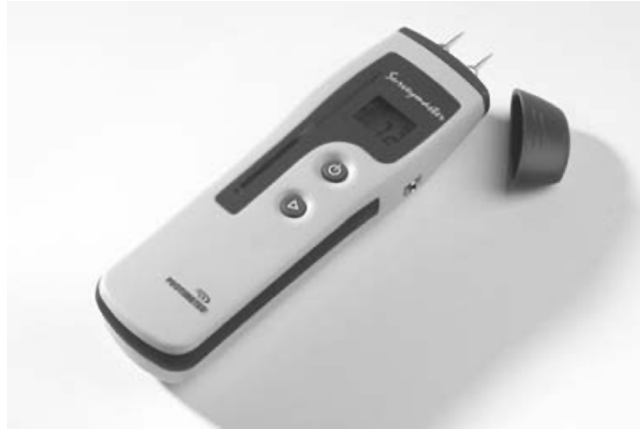
**Figure 2.3** ‘Protimeter Surveymaster SM’ moisture-reading meter (courtesy GE Sensing Infrastructure, Inc)

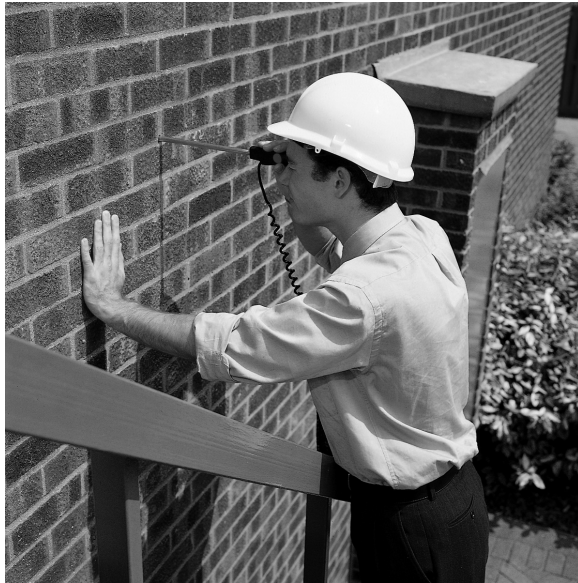
**Figure 2.4** Surveyor using a borescope (courtesy of Olympus Industrial)

- (1) Endoscopy: a fibre-optic borescope (Figure 2.4) is a useful tool for building surveyors to inspect hidden voids and cavities for problems such as bridging, wall-tie corrosion and fungal attack (Hollis, 2005) (around £1500–£4000 at 2010 prices).
- (2) Electric drill.
- (3) Electronic hygrometer (Figure 2.5): this instrument is essential for investigating condensation dampness (around £350 at 2010 prices).

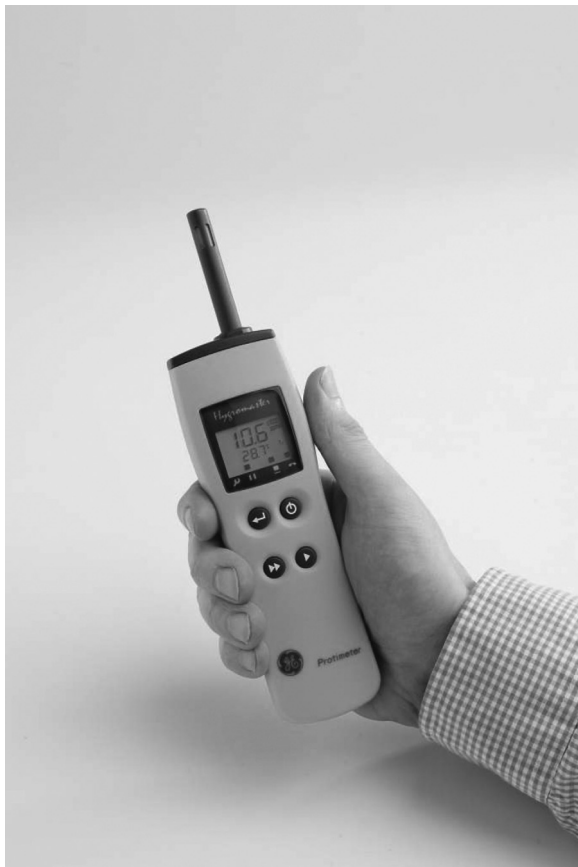
**Figure 2.5** 'Protimeter Hygromaster' hygrometer (courtesy GE Sensing Infrastructure, Inc)

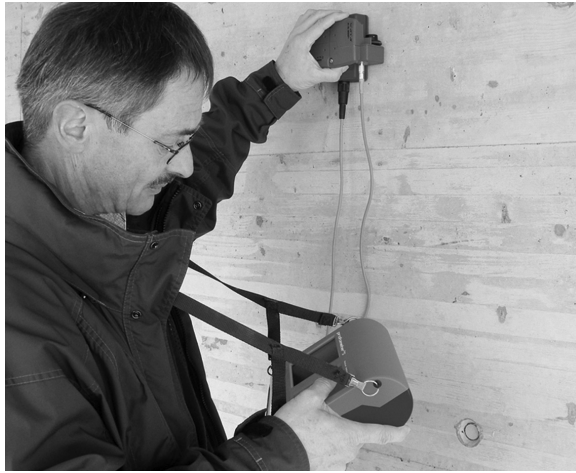
**Figure 2.6** Reinforcement detector and analysis and cover meter (courtesy of Proceq)

- (4) Cover meter (Figure 2.6): engineers and surveyors use this inspection tool to detect the presence and depth of steel bars in reinforced concrete (around £1500 at 2010 prices)

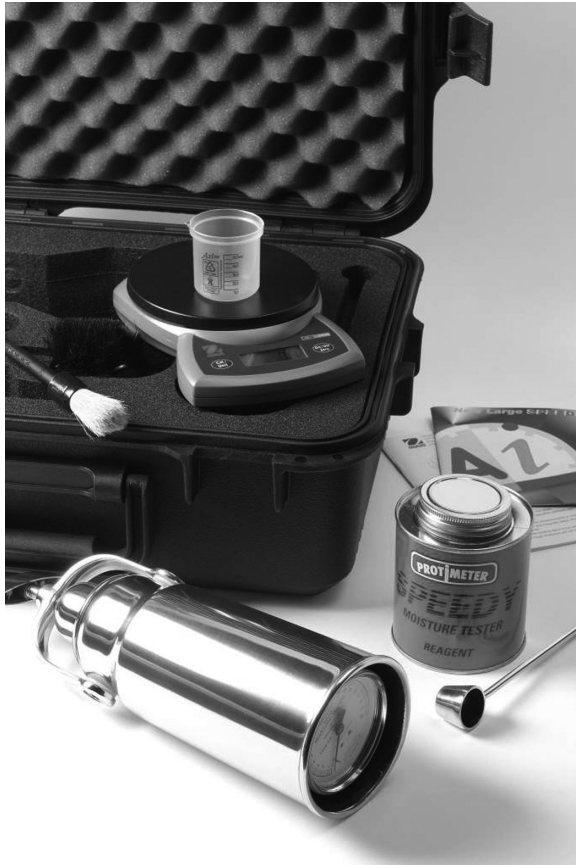
**Figure 2.7** 'Protimeter Speedy Moisture Tester' carbide meter (courtesy GE Sensing Infrastructure, Inc)

- (5) Calcium carbide ('Speedy') moisture meter (Figure 2.7): this instrument is used to ascertain on site the moisture content of particulate building materials such as mortar, brick, stone and concrete (around £700 at 2010 prices).

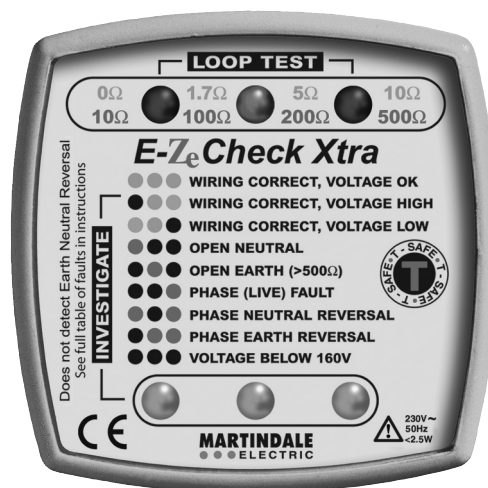
Figure 2.8 Earth loop impedance socket tester (courtesy of Martindale-Electric)

- (7) Socket tester (Figure 2.8): for use in undertaking earth safety test, voltage and wiring checks (around £50 at 2010 prices).
- (8) Micro-drilling: this is an expensive but very effective tool to determine the presence of decay in structural timbers using a special low-voltage hand-held drill that gives the result in the form of a resistograph (around £3500 at 2010 prices). Sorbus International Ltd can supply such a drill – IML-RESI F-series (<http://www.sorbus-intl.co.uk/resif-microdrill-kit.htm>).

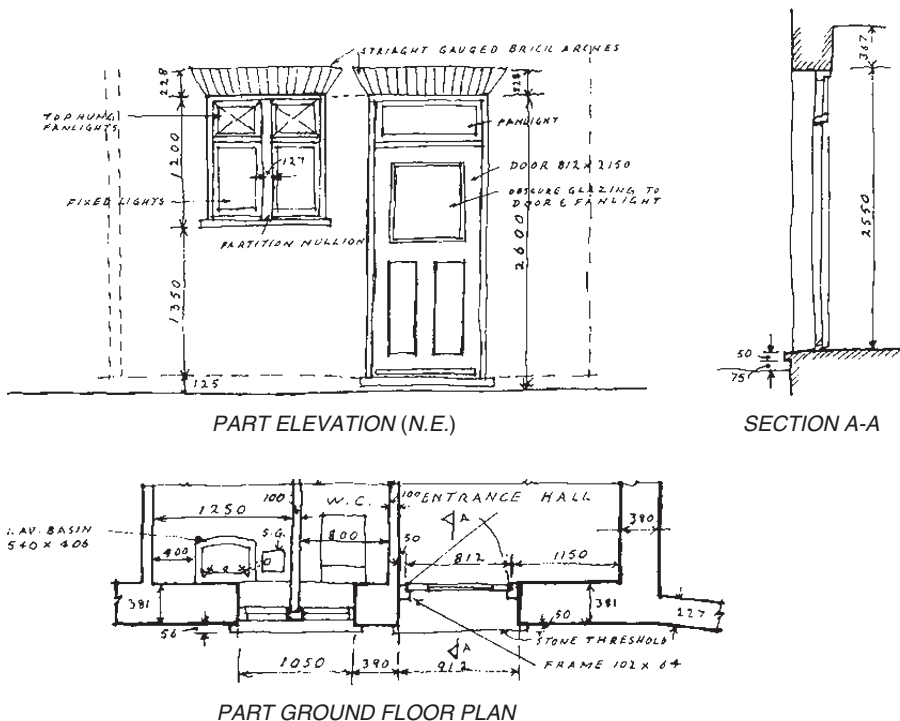
Figure 3.2 Detail of door and window openings

The heights of external door and window openings are not always required, but if alterations are contemplated they are essential if sections through the building are to be drawn. The survey sketches should show the plan and elevation of the window or door; and the dimensions must clearly indicate where they are taken; edge of frame, architrave or brickwork. Figure 3.2 suggests methods of measuring window and door openings where future alterations may be necessary. The window and door details are taken from the entrance hall and ladies toilet in Figure 3.1.

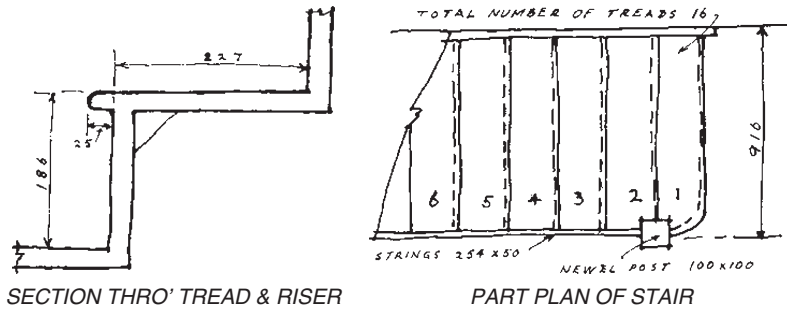
**Figure 3.3** Sketch of stair details

face of the lower riser to the face of the top riser. Enter this dimension with the number of treads on the survey sketch. The risers are similarly measured from tread to tread (see Figure 3.3). The plan and the section shown should be sufficient for a 1:50 or 1:100 scale, but details of newel posts and balustrade will probably require a larger scale.

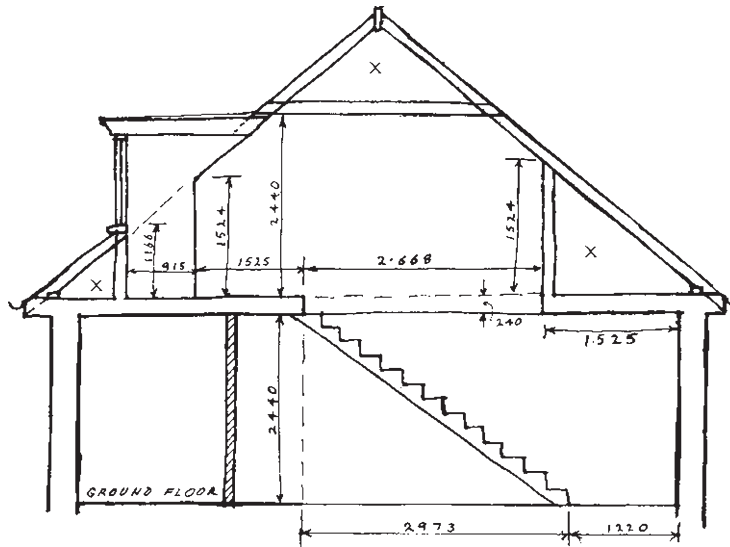
SECTION THRO' ROOF SPACE & GROUND FLOOR.  
(X=VOID SPACES, WHICH SHOULD BE VENTILATED).

**Figure 3.4** Section through roof space and ground floor

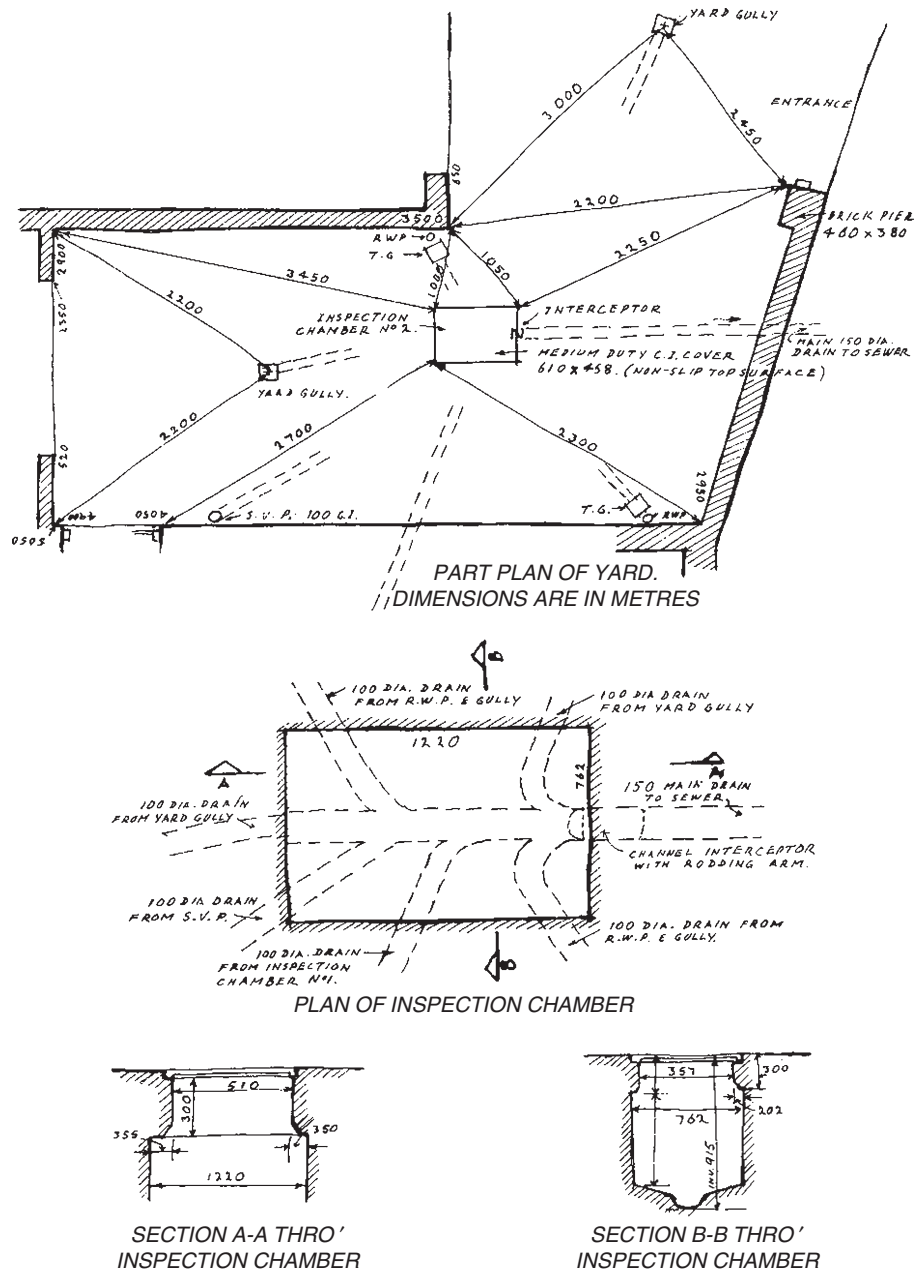
Figure 3.6 Drainage details

Inspection chamber positions can be established by taking measurements to suitable points on the external or boundary walls of the building. Figure 3.6 shows an enlarged survey sketch of the drainage system taken from the yard survey in Figure 3.1. The inspection chamber cover should be removed and the internal measurements of the chamber taken, together with the depth from cover to invert and the position and size of all pipe runs. Do not assume that the inspection chamber is the same size as the cover, as large inspection chambers are often corbelled over at the top and fitted with a small cover as shown in Figure 3.6. Trace all the drain branches by flushing WCs and running taps in basins and sinks so that every run is accounted for and at the same time note the condition of the installation.

At this stage, care should be taken not to overcrowd the sketch sheets. It is often wise to plot the drainage details on a separate sheet thus avoiding confusion when the survey reaches the plotting stage. This is why the drainage system has been omitted in the yard of Figure 3.1. Large irregular areas are often found around the boundaries of a site as shown in the yard of Figure 3.1. These are measured by taking diagonals as explained earlier in this chapter.

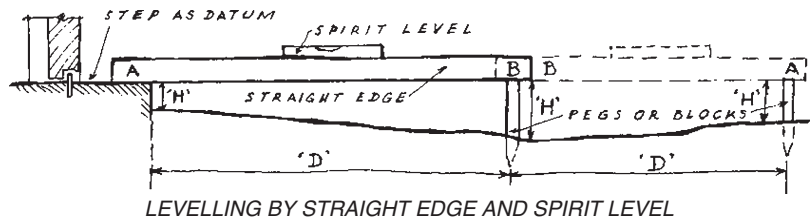
Figure 3.7 Levelling by straight edge and spirit level

as indicated by the letters 'A' and 'B' at each end of the board. By reversing the board and level any error will be minimised. The distance between the pegs or block and their height can then be measured, as indicated by the letters 'D' and 'H' on the sketch.

When booking the levels be sure to finish on the point from which you started and reduce the levels while you are on site so that any error found can then be checked and adjusted. For small extensions or alteration jobs it has often been found that only three or four approximate levels are necessary. The levels required are usually between the existing ground floor and the external paving and can be taken from an entrance using the step as a datum. In such cases, the simplest method of levelling is to use a straight edge cut from a board approximately 150 mm  $\times$  25 mm  $\times$  3 m long. The board is used in conjunction with a spirit level as shown in Figure 3.7 using a series of pegs or small blocks of timber on a flat base board. The spirit level should be checked for accuracy by reversing it on the straight edge. The bubble should come to rest in the same position. When levelling, the board and level should be reversed at each move

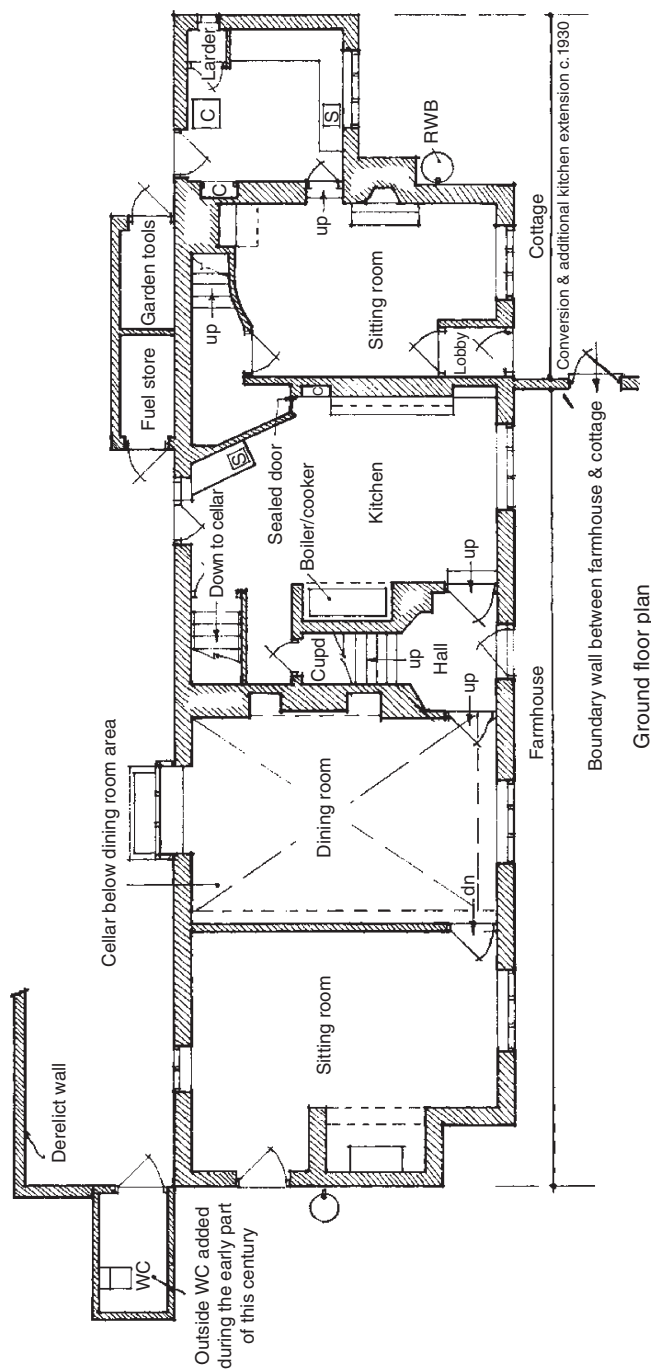
Figure 4.1 Plans

Figures 4.1, 4.2 and 4.3 show the elevations, plans and notes of an eighteenth century listed country farmhouse and cottage in Kent. This information is sufficient for a superficial layout as described above. Surveys of historic buildings for repair or restoration purposes will require more detailed information (Dallas, 2003). The primary object of this type of survey is to assist accurate diagnosis as a basis for a specification. All available evidence must be collected together and critically examined before conclusions are reached. Measured plans, elevations and sections will be required including all the items mentioned above.

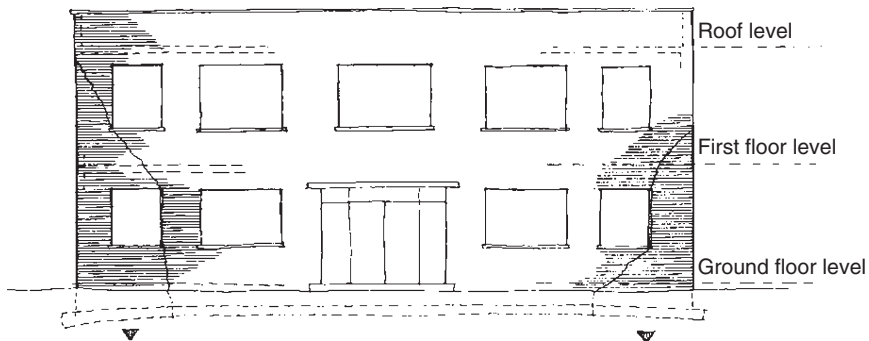
**Figure 5.1** Example of differential settlement. Settlement in end walls with centre portion stable. Cracks increase in width with height, and appear to be interrupted by the windows, but in fact extend round the openings forming a gap between window frame and brickwork. The movement is at its maximum at roof level and could cause loss of bearing in the roof slab

Excavating the ground and placing substantial loads on it is sufficient to cause a slight movement as the ground below is compressed to resist the load. Provided the settlement is uniform over the building area the movement does little damage. Alternatively, there may be differential movement where part of the foundation remains stable while the remainder moves (Richardson, 2000). A typical example of differential movement is shown in Figure 5.1 where settlement occurred in the end walls with the centre portion stable. The cracks are usually vertical or diagonal and are often interrupted by window or door openings. In such cases a gap is formed between the frame and brickwork.

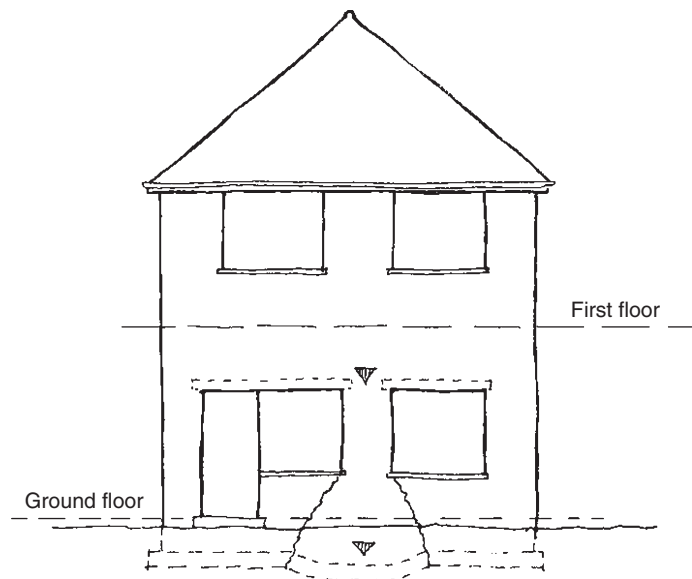
**Figure 5.2** Example of overloading. Settlement in the centre of a wall with ends stable. Heavy loads from first floor, roofs and walls above are transferred to a narrow pier of brickwork causing cracks in the wall and foundation settlement. With this type of settlement cracks decrease in width with height

Every building has its own pattern of loading. Where internal alterations have taken place in the original building or additional loads have been applied due to a change of use, then the loads placed on the subsoils are greater than was originally allowed for. Overloading can also occur where door or window openings have been enlarged which may result in a heavier load being transferred to an adjacent section of brickwork consisting of a narrow pier. Again, the load imposed upon the subsoil is greater than originally allowed for, causing the pier to settle (see Figure 5.2).

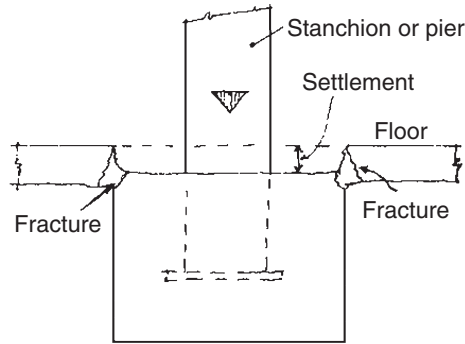
**Figure 5.3** Differential settlement under the point load of a stanchion

Under concentrated loads such as an overloaded pier or stanchion on shallow foundations will often show movement cracks between floor and foundation where the foundation has been ‘punched’ downwards sometimes several centimetres (see Figure 5.3).

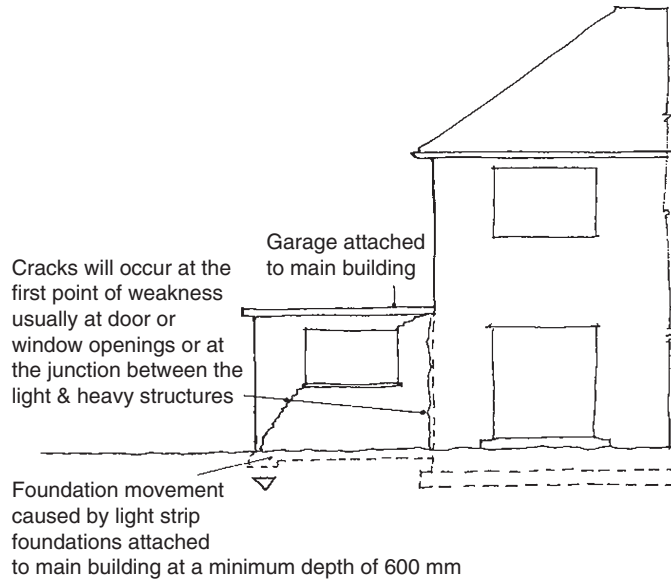
**Figure 5.5** Diagonal fracture between light and heavy structure

The surveyor will often find that foundation movement in older domestic properties can be caused by light strip foundations attached to the main building supporting porches, bay windows and garages. There is a common misconception that these lightweight structures do not need deep foundations as does the main building. If this type of foundation is not carried down sufficiently deep to avoid movement by atmospheric action, the junction between the light and heavy parts of the structure will often show a diagonal crack running down from the lower corner of the rear window as shown in Figure 5.5.

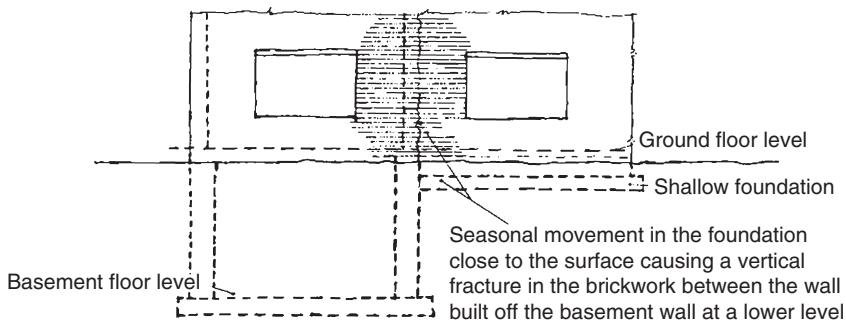
**Figure 5.6** Unequal settlement between basement and ground floor walls

Another common example is when part of a building has a basement with foundations set in deep geological beds. Seasonal movement will often take place in the foundations close to the surface causing a vertical fracture at the junction between the walls built off the basement wall and the ground floor. The heavier walls to the basement area will settle relatively more causing movement cracks between the light and heavily loaded walls as shown in Figure 5.6. This is more noticeable when the ground floor structure is built on shallow foundations in a clay subsoil.

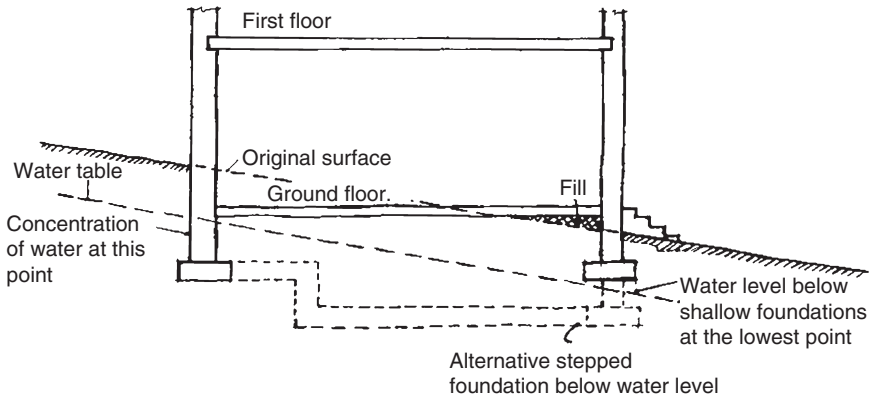
**Figure 5.7 Building on sloping clay site**

Buildings on sloping clay sites can often present difficulties (IstructE, 2000). The water table on sloping sites tends to follow the topography of the surface and if the natural contours of the site change it does not necessarily alter this line. Where the foundations have been set at a constant depth from the stepped level surface the concentrations of water may affect the foundations at the lowest point causing differential settlement. Figure 5.7 shows such a case where the water table is above the foundation at the highest point and beneath a shallow foundation at the lowest

point. In such cases it would have been advisable to form stepped foundations as shown in the sketch in order to be below the water level.

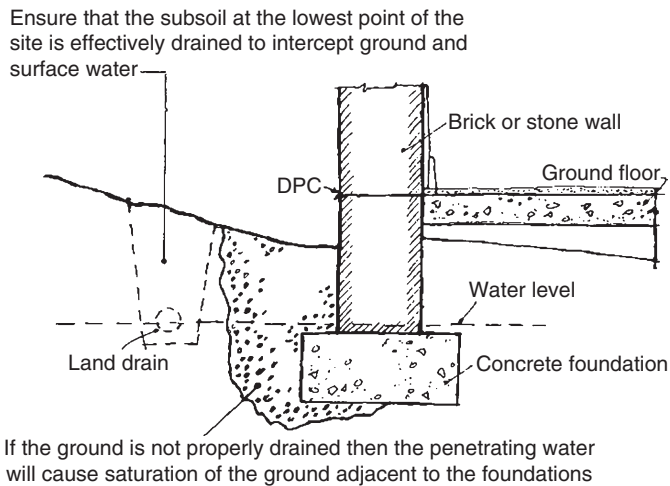
**Figure 5.8 Building at the lowest point of a sloping site**

If a building is erected at the lowest point of a sloping site, natural drainage of the water to the lower points can cause saturation of the ground around the base of the wall and foundations thus lowering the bearing capacity (see Figure 5.8). In both the above cases it is advisable to check that the subsoil is effectively drained at the highest level in order to protect the building against damage by water penetration. The surveyor will often find that surface water drainage has been omitted especially in ancient buildings.

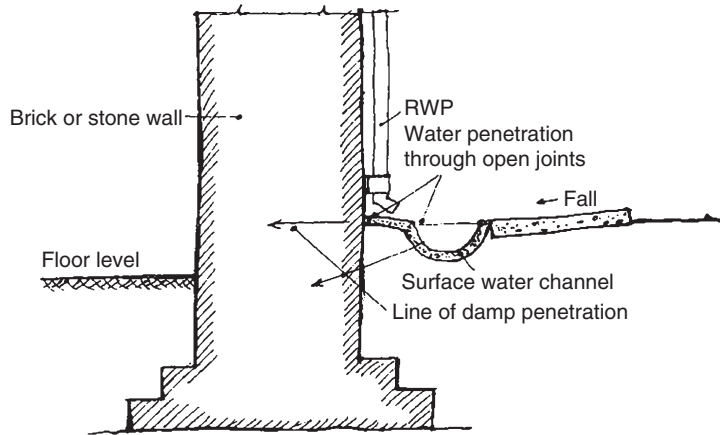
**Figure 5.9 Water penetration around base of external walls where the ground floor level is below the ground level**

surveyor will probably notice that clayware or concrete channels have been inserted around the base of the wall to collect rainwater from the roofs and a certain amount of surface water from paved areas around the building. The channels tend to move with the seasonal changes in the subsoil causing the joints to open, thus allowing water to percolate through to the subsoil and the base of the wall. In such cases there is a risk of uneven movement in the subsoil leading to settlement cracks (see Figure 5.9).

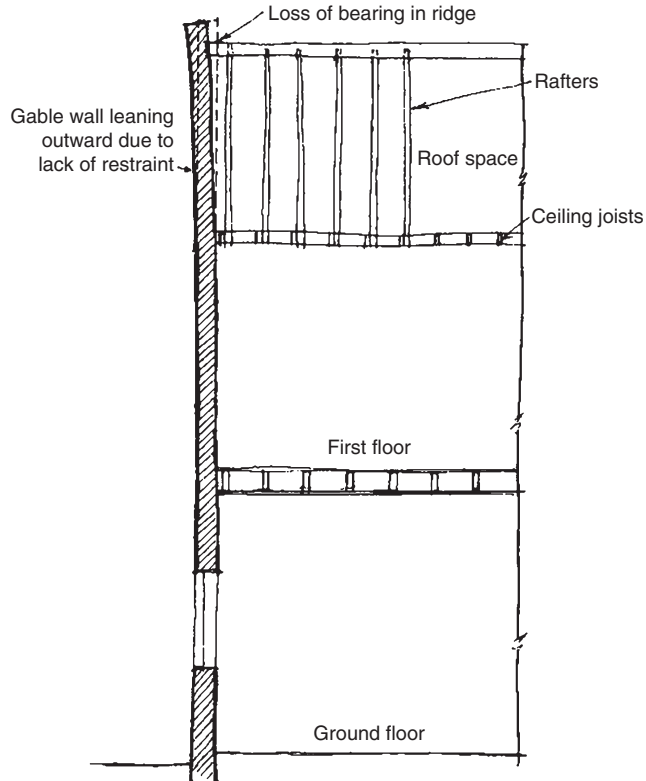
**Figure 6.2 Unrestrained flank gable wall**

of brick walls that some form of restraint should be provided to prevent lateral movement. This is achieved by building in floor joists or by bonding in partitions at right angles to the wall. In Figure 6.1 the wall is only 228 mm thick at first and second floor levels, and the floor joists run parallel to the flank wall, and do not provide a tie to the external wall. Furthermore, the staircase is positioned against the flank wall so that there is minimal restraint between flank and rear walls. If the brickwork at the junction marked 'X' on the sketch is weak a vertical fracture could develop. The flank wall will also tend to pull away from the timber stud partition as shown on the plan view marked 'Y'. These defects are common in properties built pre-1914 end-of-terrace or semi-detached three-storey houses. Figure 6.2 shows an unrestrained flank gable wall where the shortest span for the first floor and ceiling joists is front to rear. The danger in such cases is the loss of bearing to the ridge.

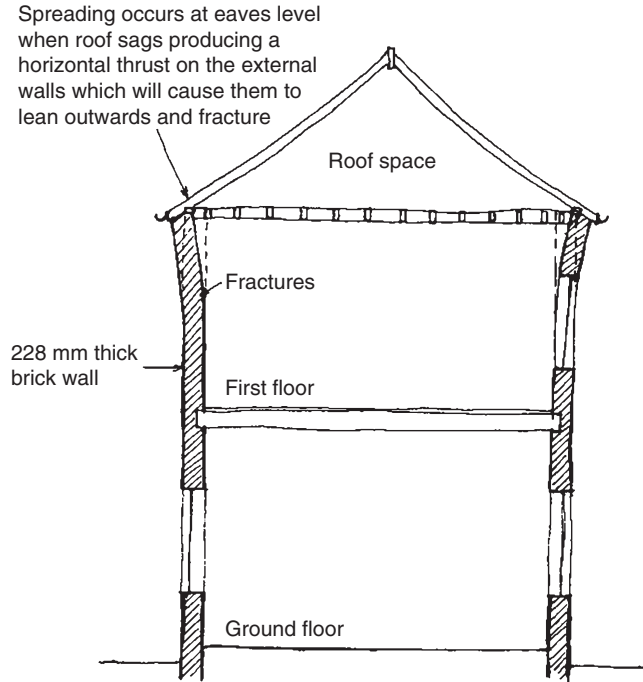
**Figure 6.3 Untied roof causing rafters to spread**

Figure 6.3 is an example of an untied roof causing the roof to sag. The sagging produces a horizontal thrust on the external walls which may cause them to lean and fracture. With all bulging and leaning defects evidence can also be seen internally by way of cracks in the ceilings, particularly at the junction of wall and ceiling, and where the partitions meet at right angles to the external wall.

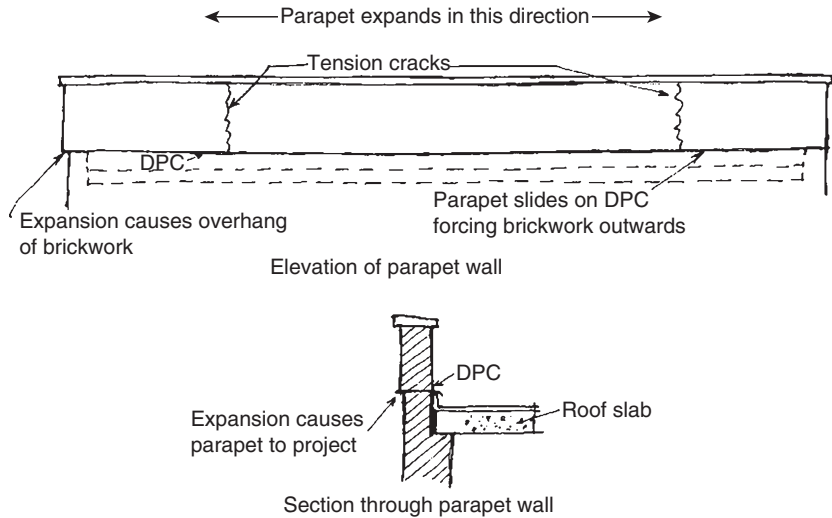
**Figure 6.5 Thermal movement of brickwork**

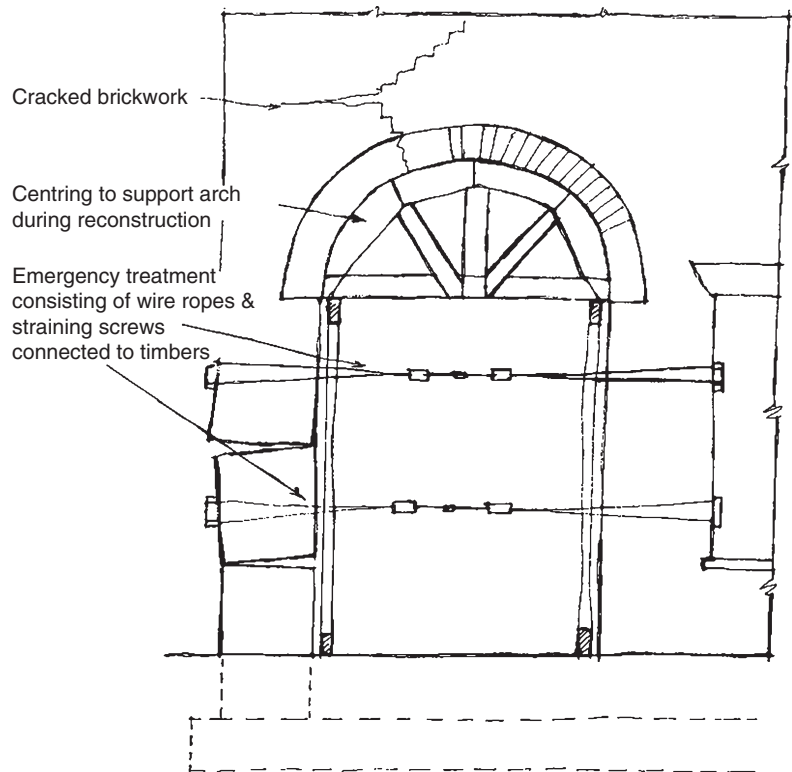
Figure 6.6 Damage to abutments due to inadequacy of the pier

Settlement cracks usually arise from the inadequacy in size of the abutments causing the brickwork to thrust outwards as shown in Figure 6.6 where the opening is too near the corner of the building. If the surveyor considers the fractures to be

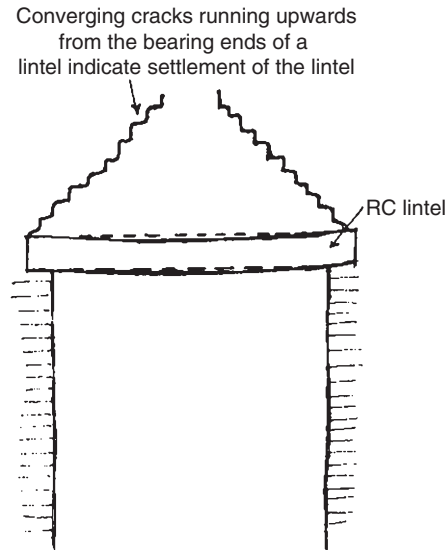
**Figure 6.7 Cracked brickwork due to lintel failure**

serious and requiring emergency treatment, the first step is to tie the abutments together by using two or three wire ropes and straining screws connected to timbers through the nearest opening. The arch will also require support by erecting centring similar to that used in the construction of new arches. This will relieve the arch of its load and enable the necessary repairs to be carried out. Alternatively, a raking shore should be erected against the fractured abutment to resist any further movement. A similar problem can arise from the excessive deflection of a lintel, causing converging cracks to run upwards as shown in Figure 6.7.

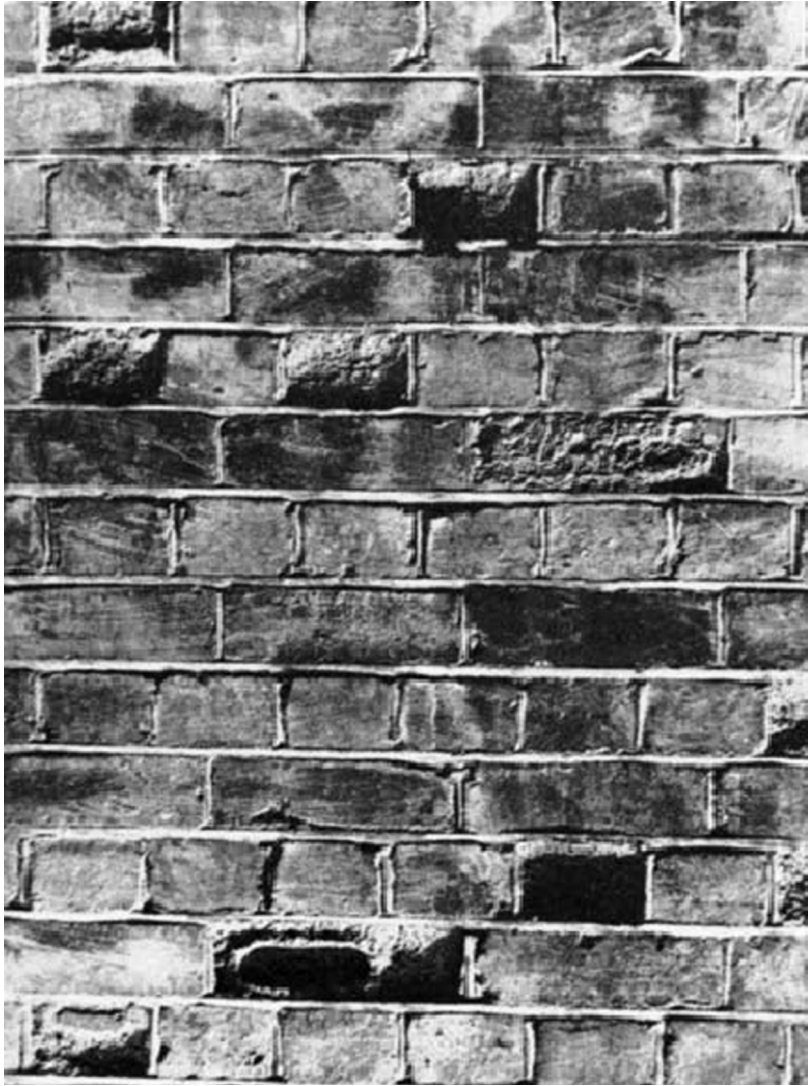
**Figure 6.8** Surface decay of brickwork due to crystallisation of salts

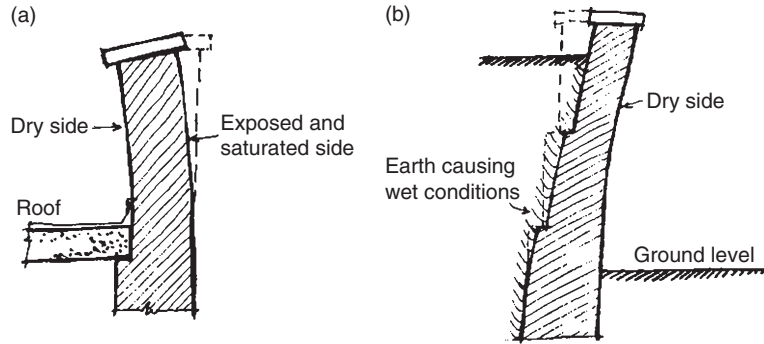
**Figure 6.9 Sulphate attack (a) in parapet wall and (b) brick retaining wall**

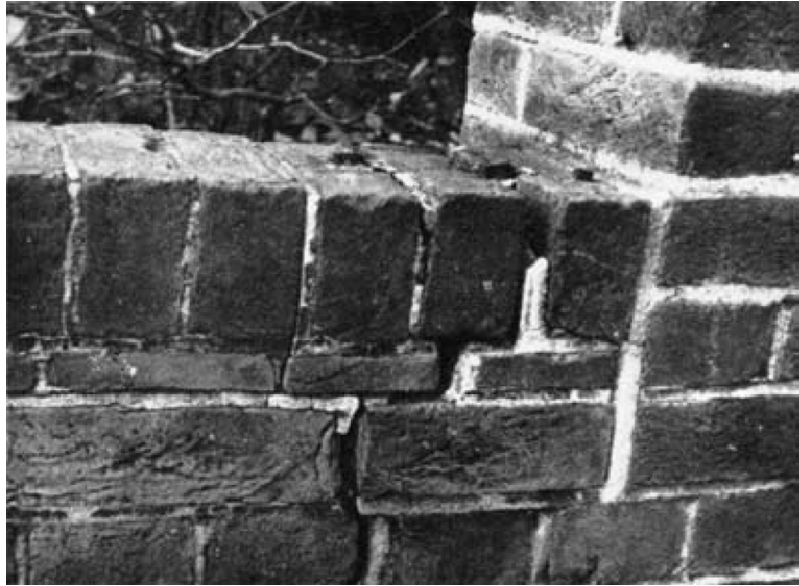
**Figure 6.10 Cracking of brickwork due to corrosion of embedded steel**

Iron and steel members embedded in brickwork can well be affected by corrosion causing the surrounding brickwork to fracture and loosen. In order to diagnose the full extent of the problem, the surveyor will usually find it necessary to remove the surrounding brickwork in order to gain access to the metalwork. Figure 6.10 shows a typical example. Rusting steel stanchions encased in brick cladding may produce vertical cracks.

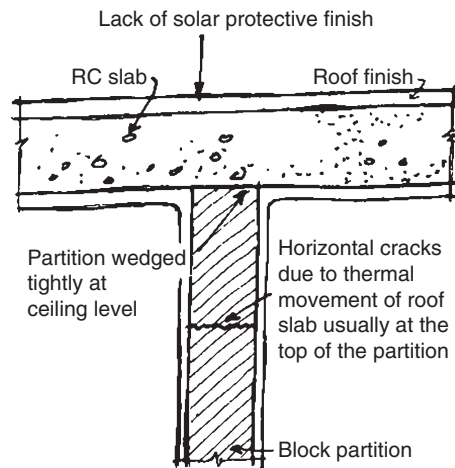
**Figure 6.11 Partition failure due to thermal expansion of roof slab**

Another type of failure is associated with the thermal expansion of a concrete roof slab to which the flat roof system is prone. This occurs where the partition has been wedged tightly at ceiling level without allowance in the design for the differential movement between the roof slab and partition. The thermal movements of the slab produce horizontal cracks near the top of the partition as shown in Figure 6.11. This failure is also due to the lack of solar-protective finish on the roof covering; if adequate this would reduce the amount of heat absorbed by the roof slab.

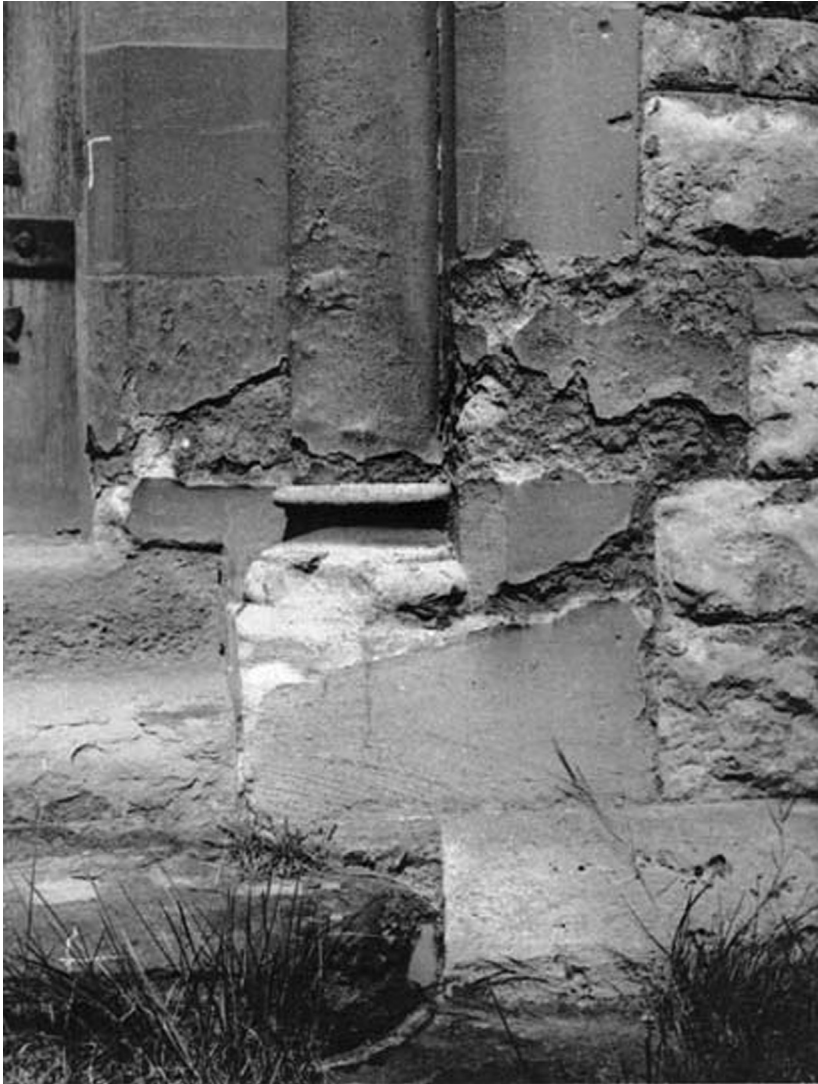
**Figure 6.13** Surface blistering of Bath stone and Kentish rag stone due to atmospheric pollution

Atmospheric pollution is the principal cause of deterioration of limestone and sandstones (Richardson, 2001). Air usually contains impurities of sulphur and carbon. Sulphuric gases in the atmosphere dissolve in rainwater to form acid solutions and, when not freely washed away by rain, these form a hard skin on the limestone eventually causing surface blistering, scaling and the formation of cracks at arrises (Cook & Gibbs, 1993). When the surface blistering breaks off, it pulls away some of the limestone with it. Sulphur gases can also attack calcareous sandstone in a similar manner. Pollution deposits are widely dispersed and travel with the wind and rain, although the effect is more noticeable in urban and industrial districts. Figure 6.13 shows an example of surface blistering of Bath stone and Kentish rag stone due to atmospheric pollution.

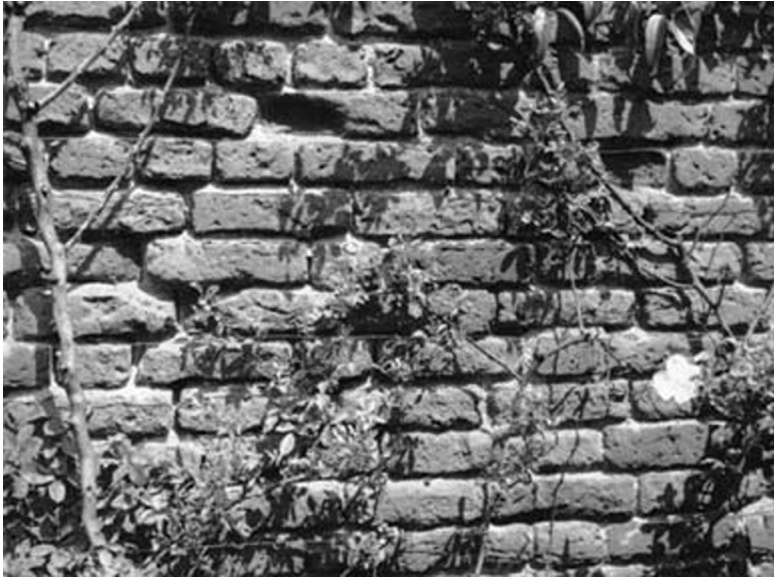
**Figure 6.14** A fairly common defect caused by shrubs sending their roots into brick joints

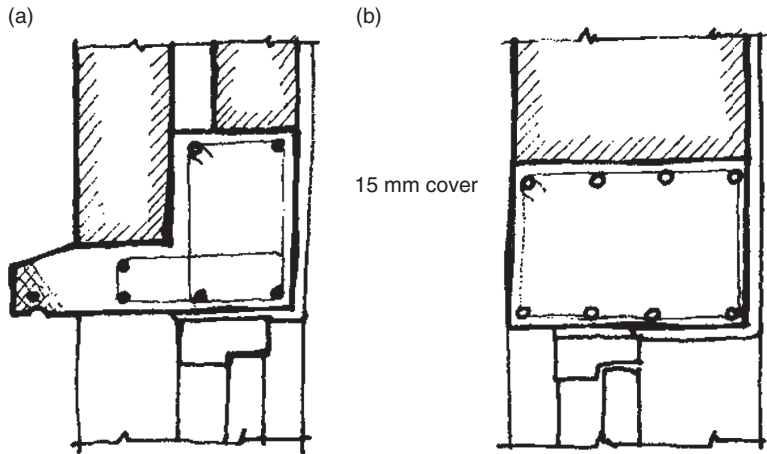
**Figure 7.1** (a) Cracking of concrete in projecting nib of lintel. Reinforcement not required to projecting nib. Damp penetration will cause corrosion and spalling of concrete. (b) Reinforcing bars too near the surface causing concrete to crack and bars to corrode. In both cases cracking of the concrete will occur allowing moisture to penetrate and concrete to spall off

It is important that the surveyor checks the depth of the cover, especially in small members such as window sills, string courses and projecting nibs to reinforced concrete lintels as shown in Figure 7.1a. If the reinforcing bars are too near the surface the concrete will crack and the bars corrode. Loose portions of concrete can be removed fairly easily and should not present the surveyor with any difficulty. When dealing with cracks it is often necessary to enlarge the crack to gain access to the steelwork before a correct diagnosis can be obtained.

In some cases it may be found that the reinforcing bars are too close together to allow the aggregate to pass freely between the bars and formwork as shown in Figure 7.1b. Figure 7.2 shows an example of reinforcement corrosion causing cracks to appear in the concrete cover. Cracks can also be caused by structural movement or defects in the foundations; if the cracks continue down below the ground this would suggest some defect in the foundations, possibly due to settlement.

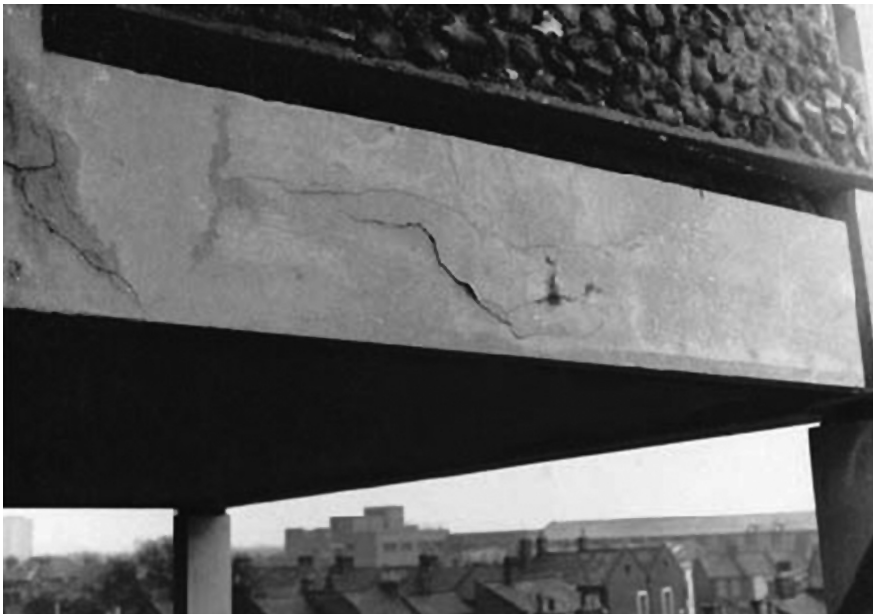
**Figure 7.2** Corrosion of reinforcement causing cracking of concrete. Reproduced by permission of Harsco Infrastructure

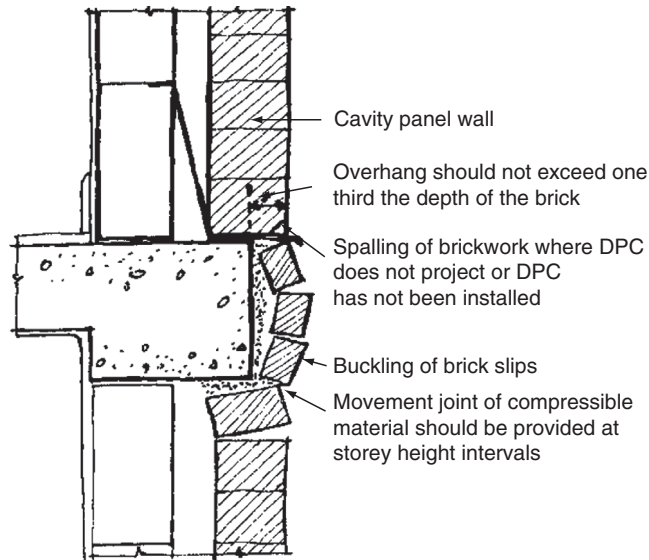
**Figure 7.3** Movement in concrete structure due to creep of concrete frame and expansion of brick panel walls

Where brickwork is supported on reinforced concrete beams or 'nibs', brick slips are often used to cover the edge of the beam. In recent years there have been a number of failures due to the brick slips buckling. It is usually attributed to the expansion of the brickwork or 'creep' of the concrete frame (see Figure 7.3). Conventional mortars and adhesive have proved inadequate for fixing the brick slips. A considerable amount of research has been carried out in this field by the Brick Development Association (BDA) and the use of special mortars such as polyester resin or styrene butadiene rubber (SBR) emulsion is now recommended. If the brick slips are to be replaced it is advisable to recommend that they should be isolated by compression joints from the brick panels. One of the important points that should be checked is the overhang of the outer skin of brickwork as shown in Figure 7.3. The overhang should not exceed one third the depth of the brick. The position of the DPC is also important and should project beyond the outer face of the brickwork to prevent spalling of the lower edge of the brick.
